Building Condition Survey (Example)

BUILDING CONDITION REPORT

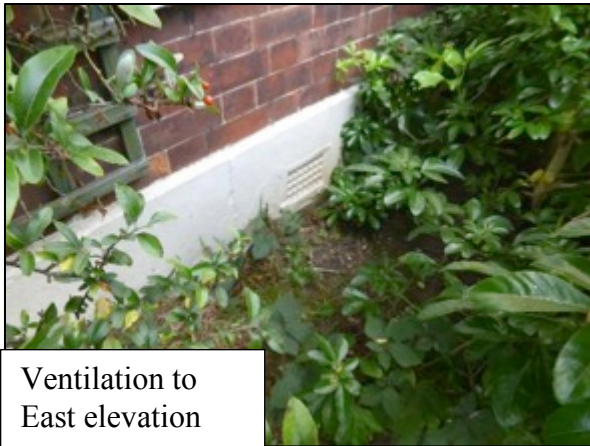
- 3.01.09 External stairways** –None present
- 3.01.10 DPC** – None present
Condition – No significant defects noted.
Action – None
- 3.01.11 Sub-floor ventilation** – Ventilation bricks were located to all the elevations, and were noted to be above eternal ground levels and free of debris.

Ventilation to
East elevation

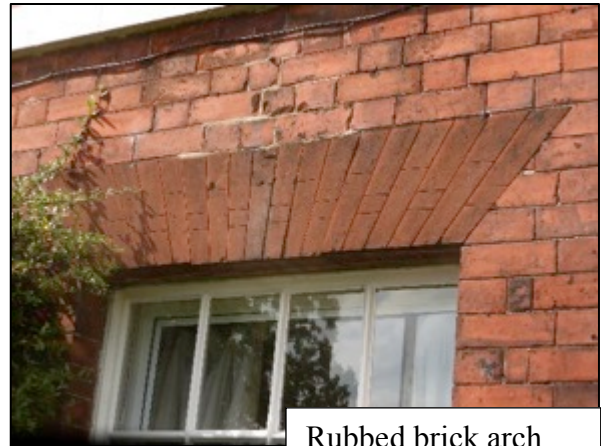
Rubbed brick arch
above East window
to GF02

Georgian lintel to window of GF02 - Remove previous repair pointing to, re-align rubbed brickwork arch keystones, and repoint in lime putty mortar. £

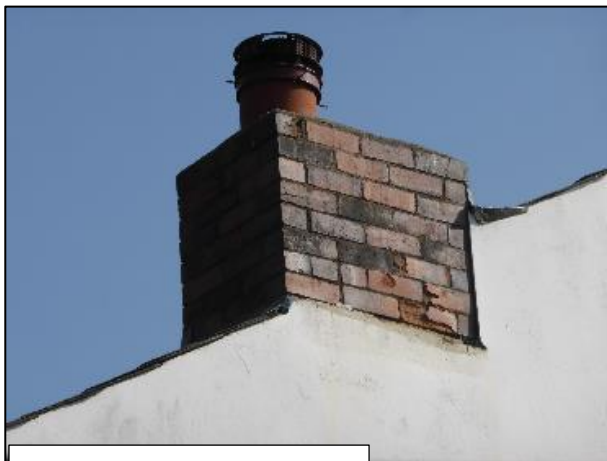
Condition – It was noted that some brickwork surfaces were starting to spall, and the condition of the head flaunching was deteriorating.

Poor render detail to
South West chimney
CH01

Action – Undertake repairs to flaunching and pointing of brickwork to both chimneys. (Maybe consider rebuilding and increasing height?) £

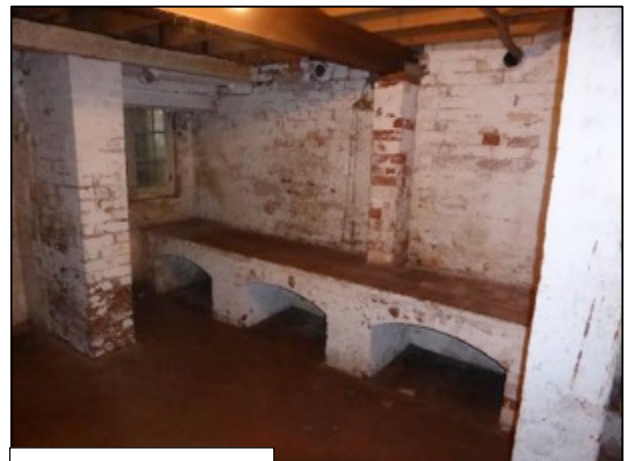
Basement BF01

- 3.02.08 Cellar and Vaults** – Comprising a single basement accessed from the ground floor in GF01, via a brick staircase. Ventilation pits and windows were located to the North and East elevations. A sump pit was located within the brick paved floor.
Condition – The area was sufficiently ventilated. It was noted that the timber window units were in need of refurbishment, and there was no evidence of a sump pump.
Action – Modification or refurbishment of ventilation windows. £
Installation or investigation of sump pump requirement. £

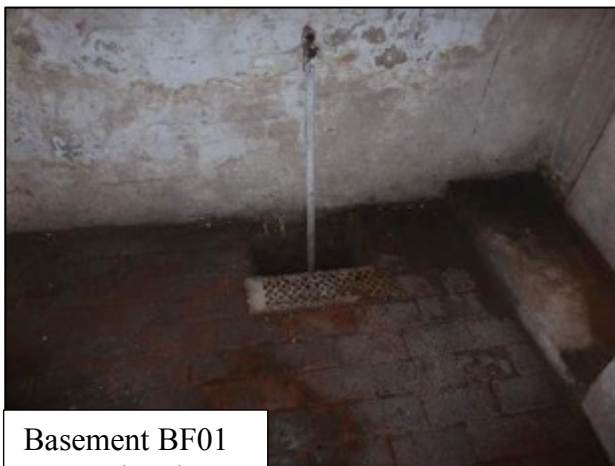
Basement BF01
Sump chamber

• Fire proofing and rust treatment to basement steel beams	£
• Installation / investigation of basement sump pump	£
Total	£

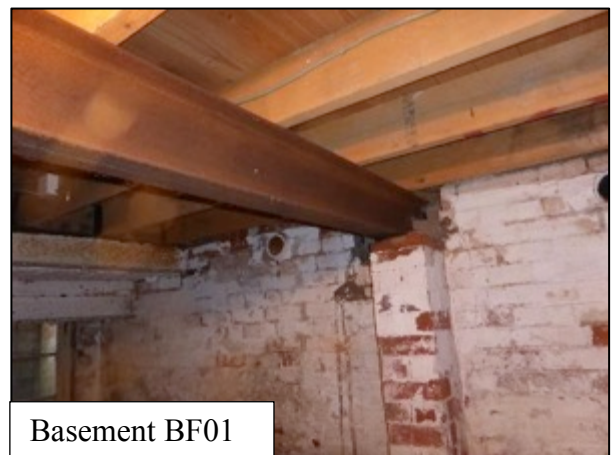
Significant corrosion (not structurally damaging) was noted to the steel beams within the basement, and they were also noted to be without any fire protection, which is now a requirement within the building regulations. Insulation was also not present to the timber floor above the basement (GF06), and an increase in the main loft insulation may be beneficial to the overall thermal performance of the building.

Basement BF01
Corroded beam

- 3.02.04 Beams and columns** – Comprising open steel beams within the basement BF01. There were no identifiable columns, and the majority of timber floor beams were integral to floor structures and beyond ceiling surfaces.
Condition – No significant defects were noted to visible timber floor beams.
Action – The steel beams with the basement are recommended to be prepared and treated with a rust inhibitive paint, or coated in an intumescent spray finish to provide sufficient fire protection for the upper floor structure. £
